**Project PAJ3 - Combined Cyclic Loading
and Hostile Environments 1996-1999**

Fractographic Analysis of Adhesive Joints

M R L Gower and W R Broughton

October 1999

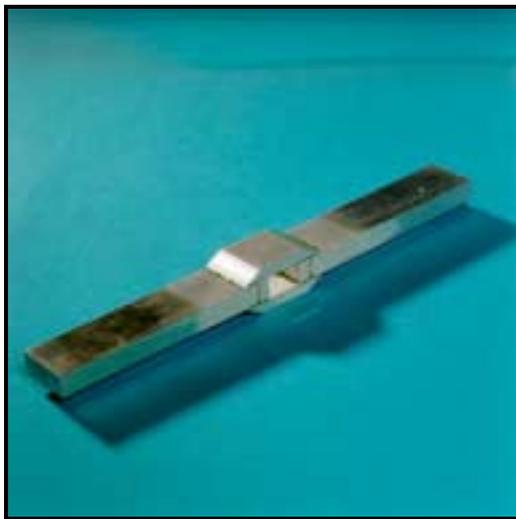
Figure 2 A typical tapered-lap joint.

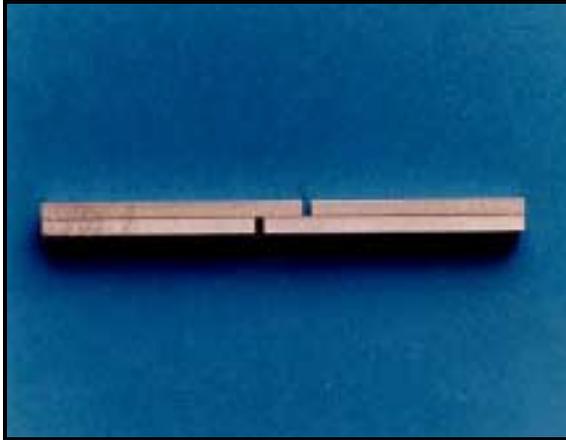
Figure 5 A typical tension TAST specimen (side view).

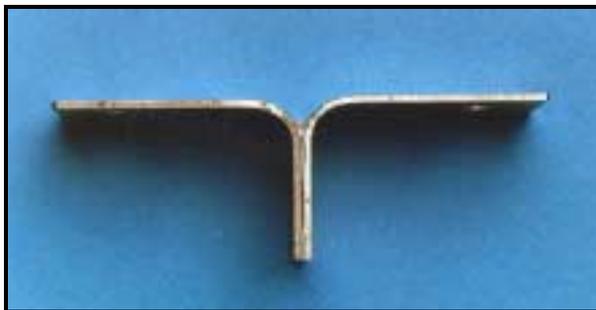
Figure 12 A typical T-peel joint.

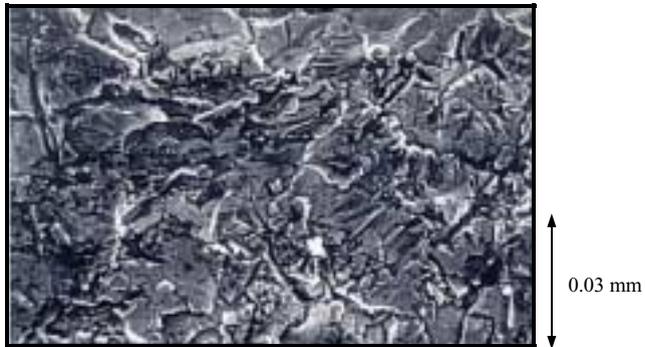
Figure 17 Surface appearance of grit blasted mild steel (x 900 magnification)

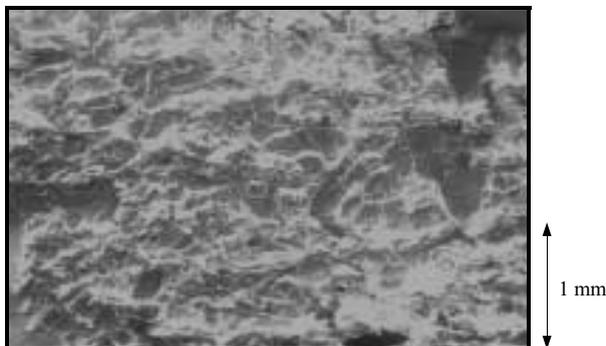
Figures 35 to 37 show typical fracture surfaces for the aluminium 5251 alloy + AV119 specimens after different levels of environmental conditioning. As previously stated, aluminium TAST specimens with AV119 adhesive showed a predominantly cohesive failure with a slight amount of interfacial fracture. The mode of failure was independent of conditioning regime. Figure 35 shows the fracture surface of a TAST specimen having undergone no conditioning and both cohesive and interfacial fracture can be seen. Figure 36 depicts an area of interfacial fracture on the failure surface of a specimen tested after 42 days exposure to water at 25°C whilst Figure 37 illustrates the largely cohesive type of failure typical of aluminium 5251 alloy + AV119 TAST specimens.

Figure 35 Typical fracture surface of an Al 5251/AV119 TAST specimen tested in static tension - no conditioning. (x24 magnification).

Figure 36 Typical fracture surface of an Al 5251/AV119 TAST specimen tested in static tension - no conditioning. (x24 magnification).

Figure 37 Typical fracture surface of an Al 5251/AV119 TAST specimen tested in static tension - no conditioning. (x24 magnification).

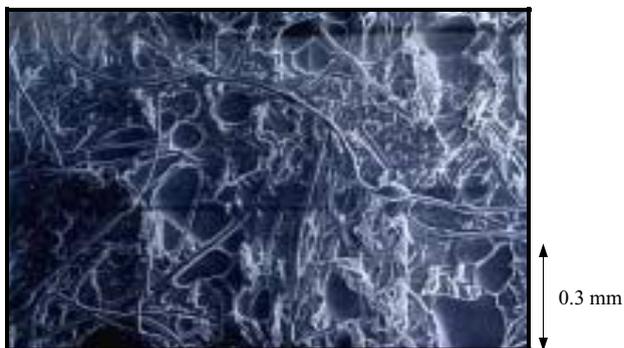
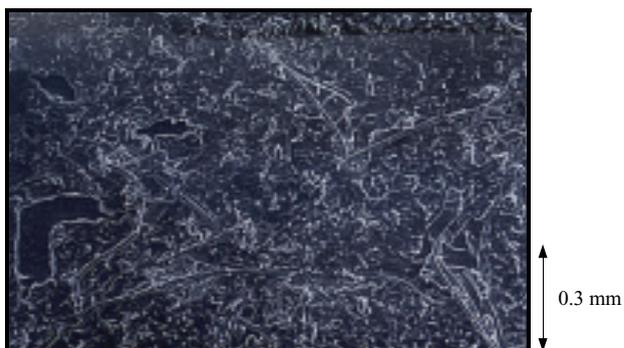
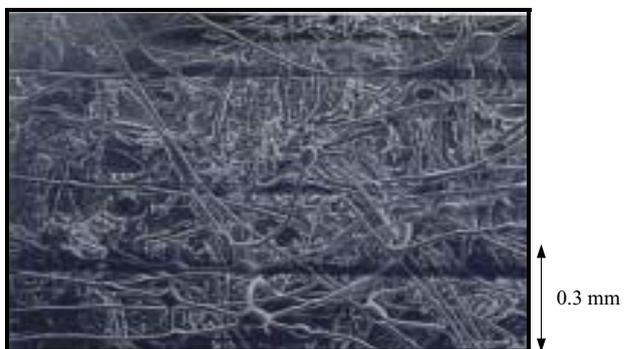
Figures 38 to 40 show the failure surfaces of aluminium 5251 alloy + AF126-2 TAST specimens. The failure mode is cohesive and independent of conditioning regime as the figures show.

Figure 38 Typical fracture surface of an Al 5251/AF126 TAST specimen tested in static tension - no conditioning. (x75 magnification).

Figure 39 Typical fracture surface of an Al 5251/AF126 TAST specimen tested in static tension after 42 days water immersion at 25° C. (x75 magnification).

Figure 40 Typical fracture surface of an Al 5251/AF126 TAST specimen tested in static tension after 42 days water immersion at 60° C. (x75 magnification).

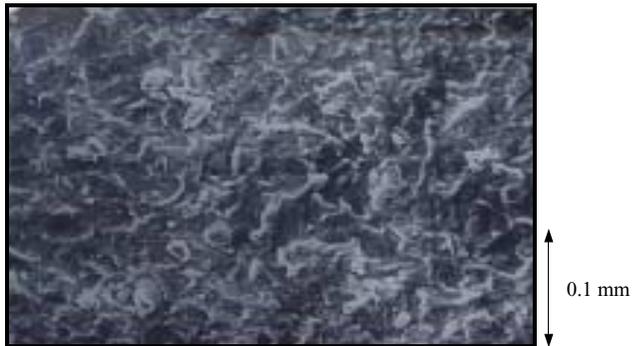
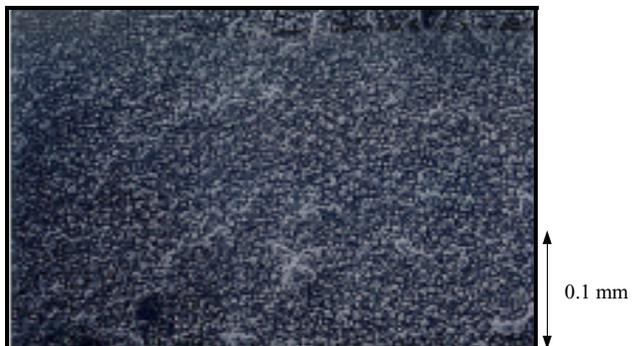
Figures 41 to 43 are micrographs of Al 5251 + F241 specimens. All failures were interfacial with failure always occurring at the interface corresponding to the surface on which the adhesive had been applied - see Section 3. It is apparent from the micrographs that changes in the structure of the adhesive occur when specimens immersed in water at elevated temperatures. A transition can be seen from the unconditioned state (Figure 41) through to 42 days in water at 60°C (Figure 43). As the length of exposure increases, the surface of the adhesive becomes 'flaky' and then rather granular. The manufacturers of F241 adhesive could not wholly explain (2, 3) this phenomena, but it is thought that exposure to temperatures above 60°C can cause some degradation of the adhesive. The F241 adhesive is based on a chlorosulphonated rubber with a methyl methacrylate resin and water immersion may cause some hydrolysis of the methyl methacrylate resin resulting in swelling of the resin. The combination of elevated temperature and immersion to water is likely to be the cause in the change of structure of the adhesive. It was observed that the strength of the joint initially increased before steadily decreasing with exposure time. This is an indication that the adhesive was post curing during the early stages of conditioning.

According to the manufacturer, F241 adhesive should be a white colour if the correct proportions of adhesive and initiator have been used. If too much initiator is used then the adhesive is usually a light brown or caramel colour. The adhesive resin absorbs the initiator on application and any excess initiator will spread out over the surface of the adhesive like an oil film. If this occurs then a weak layer will be formed between the adhesive and the adherend, reducing the strength of the bond. However, as all the bonds failed on the adhesive side, it is most likely that the correct amount of initiator was used and the brown colouring was as a result of the adhesive being exposed to light after failure.

Figure 41 Typical fracture surface of an Al 5251/F241 TAST specimen tested in static tension - no conditioning. (x250 magnification).

Figure 42 Typical fracture surface of an Al 5251/F241 TAST specimen tested in static tension after 42 days water immersion at 25°C. (x250 magnification).

Figure 43 Typical fracture surface of an Al 5251/F241 TAST specimen tested in static tension after 42 days water immersion at 60°C. (x250 magnification).
