**VAMAS TWA 22
Mechanical Property
Measurement of Thin
Films and Coatings**

**A ROUND ROBIN TO
MEASURE THE
ADHESION OF THIN
COATINGS**

**G Aldrich-Smith¹, N.M. Jennett¹
& J Housden²**

September 2004

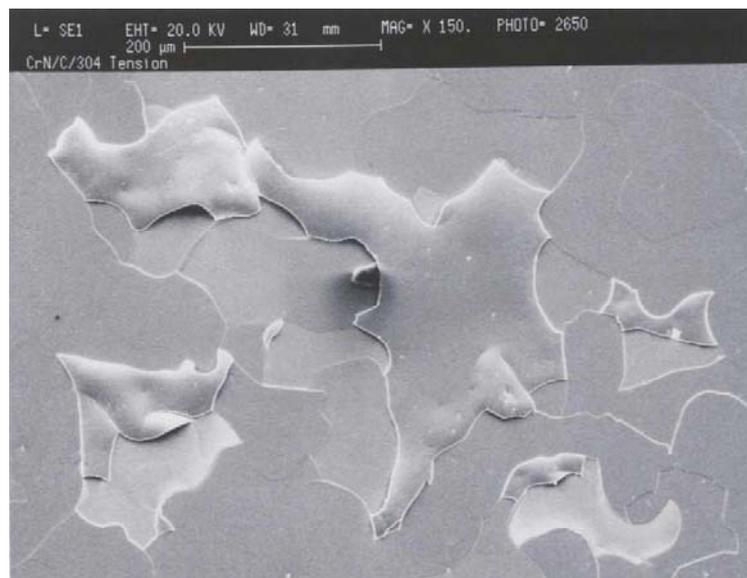
Figure 1. CrN coating on AISI 304 stainless steel with carbon interlayer. Coating spallation induced by differential thermal expansion coefficients when cooling from deposition temperature.

Adhesion of CrN was controlled using a thin interlayer. For the scoping study two interlayers were designed to reduce adhesion. An Au/Pd (60:40 wt.%) interlayer was intended to provide a ductile region between coating and substrate and disrupt any chemical bonding between coating and substrate. This was deposited on polished coupons using a small sputter chamber designed to apply conductive coatings for scanning electron microscopy (SEM) specimens. Coating thickness was measured gravimetrically at ~35nm. The second interlayer was an amorphous carbon layer again used to contaminate the interface and reduce chemical and mechanical bonding. The carbon interlayer was deposited using a carbon arc evaporator, similarly designed for SEM work. Several arc pulses were required to get a visible coating. After deposition of the CrN coating on the carbon interlayer large scale delamination of the coating from the substrate was observed. The carbon interlayer had reduced adhesion so much that when cooling from deposition temperature the differential thermal contraction of the coating and substrate was enough to cause the coating to spall (**Figure 1**). The Au/Pd layers did not result in spallation. Rockwell indentation and 4 –point bend testing showed some differences in coating adhesion. Therefore the Au/Pd interlayer was chosen for the ILE coupons and the thickness was varied to obtain different adhesion levels. It was hoped that the ILE test results would allow discrimination between coatings with and without an interlayer and between the different interlayer thicknesses.

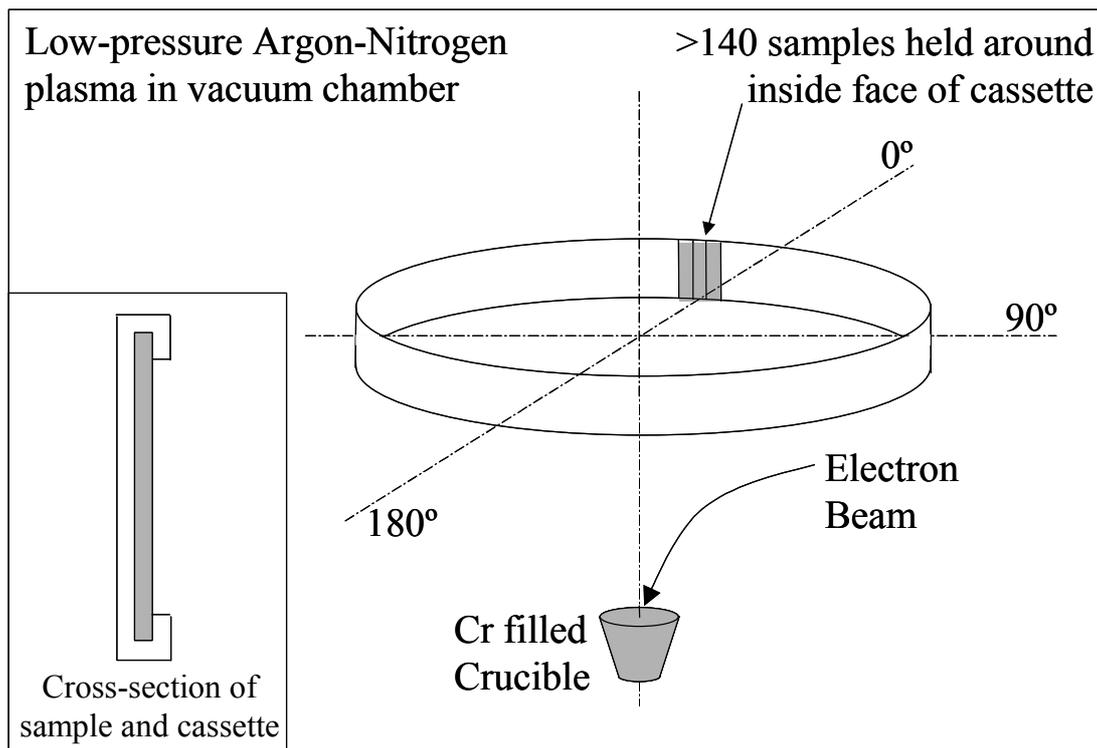
Figure 2. Schematic of EB-PVD coater. Up to 140 coupons held parallel to coating flux in a novel cassette. Insert shows a cross section of coupon and cassette.

About 400 samples were required for the ILE and so the 'one off' sample preparation route, used in the scoping study, was modified. Twenty-five and fifty nm thick interlayers of Gold-Palladium (60:40 wt. %) were deposited at NPL using electron beam physical vapour deposition (EB-PVD). Thickness was controlled with a piezo-crystal based thin film monitor. Measurements of coating reflectance indicated that the 25nm thick films were not fully dense. The coupons were subsequently coated with CrN to an NPL specification, deposited by reactive EB-PVD at Tecvac Ltd, a UK coatings supplier. A novel cassette was developed by Tecvac to allow a large number of coupons to be coated in one batch (**Figure 2**). A nominal CrN coating thickness of 5 μ m was applied to three batches of 130 substrates grouped by interlayer type (no interlayer, 25nm interlayer and 50nm interlayer).

Variations in coating thickness were observed both within coupon, within batch, and between batches. Within the coupon the coating thickness was greater at the bottom of the specimen compared to the top. This was expected as the bottom of the coupon was closer to the EB-PVD crucible (**Figure 2**) and would have received an increased coating flux. Thickness variations with the batches could have been caused by slight mis-alignment of the coupon cassette over the crucible. Residual stress in the coatings followed broadly similar trend to within batch coating thickness (**Figure 4**). CrN thickness varied between batches by about 10%.

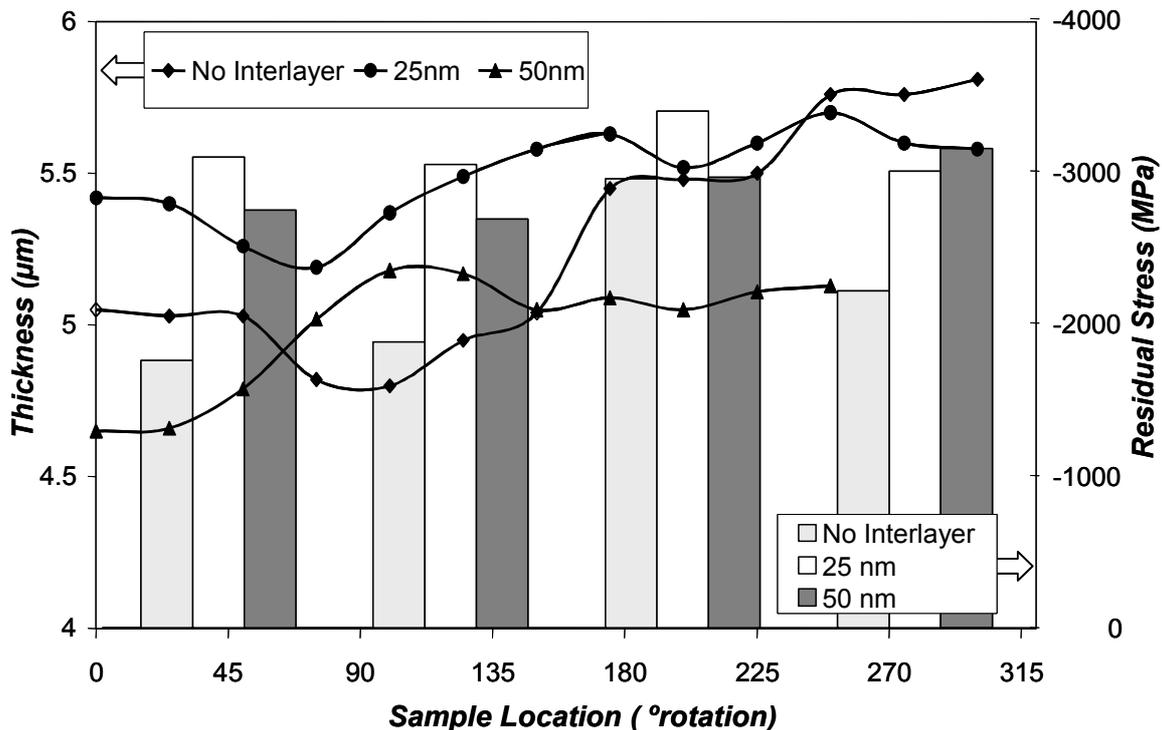
Figure 4. Average thickness and residual stress for ILE coupons. Thickness (line chart) was measured on every tenth coupon per batch, position shown relative to 0° line on cassette in **Figure 2**. Residual stress was measured by XRD on four coupons per batch equispaced around the cassette.

Values for hardness and modulus for each coupon type are given in **Table 1**. One coupon per interlayer thickness was tested. The CrN coated coupon with the 25nm thickness interlayer had an elastic modulus nearly 20% higher than the others, residual stress (**Figure 4**) for this batch was also higher. The reasons for this are not known but this could have resulted from several mechanisms, i.e., a slight variation in process stoichiometry leading to deposition of a CrN analogue, such as a mixture of CrN and Cr₂N.

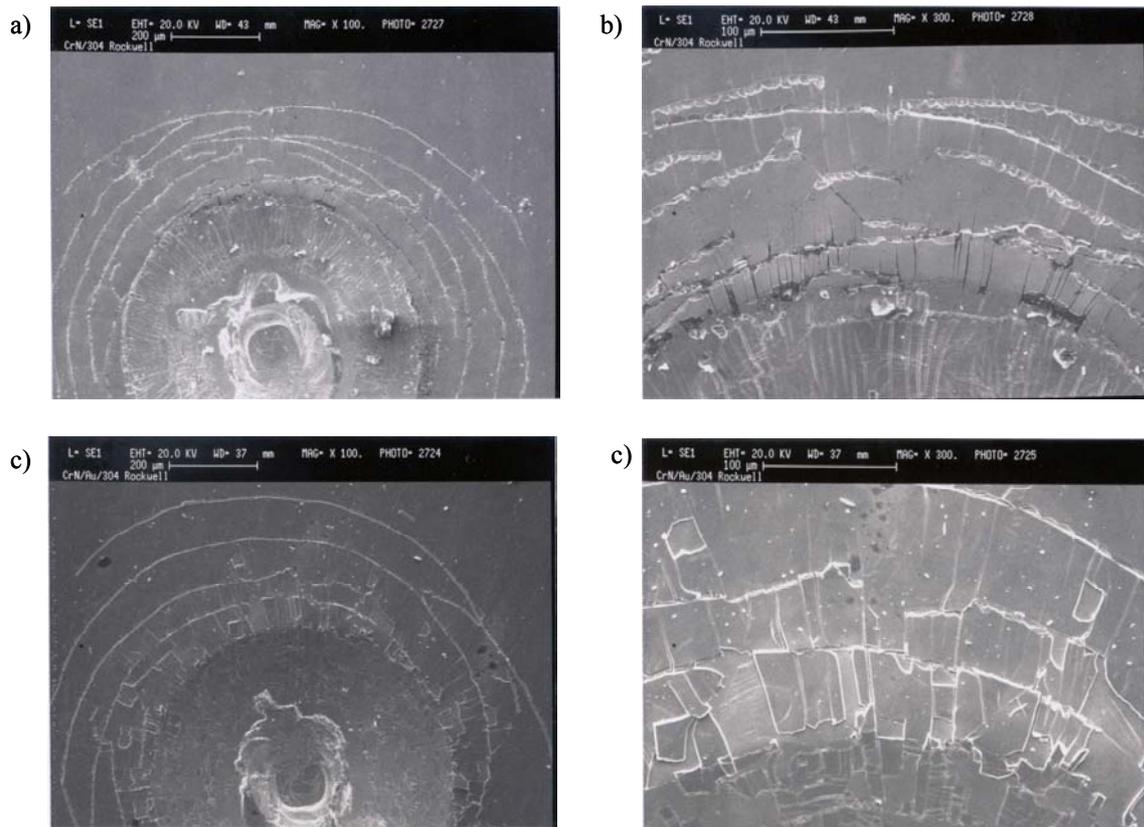
Figure 5. Scanning electron micrographs of Rockwell indents from the scoping study. a-b) CrN coating, no interlayer; c-d) CrN coating, 35nm gold-palladium interlayer.

SEM micrographs of indents from the scoping study are shown in **Figure 5**. The CrN_{NO} INTERLAYER coupon (**Figure 5a-b**) showed increased Hertzian (ring) cracking around the indent compared to the CrN_{Au/Pd} INTERLAYER coupon (**Figure 5c-d**). These cracks had cohesive micro-spallations along the length, similar to those observed with the high load scratch tests. Both coupons showed radial cracks extending out from the indent. With the CrN_{Au/Pd} INTERLAYER coupon these induced coating delamination.

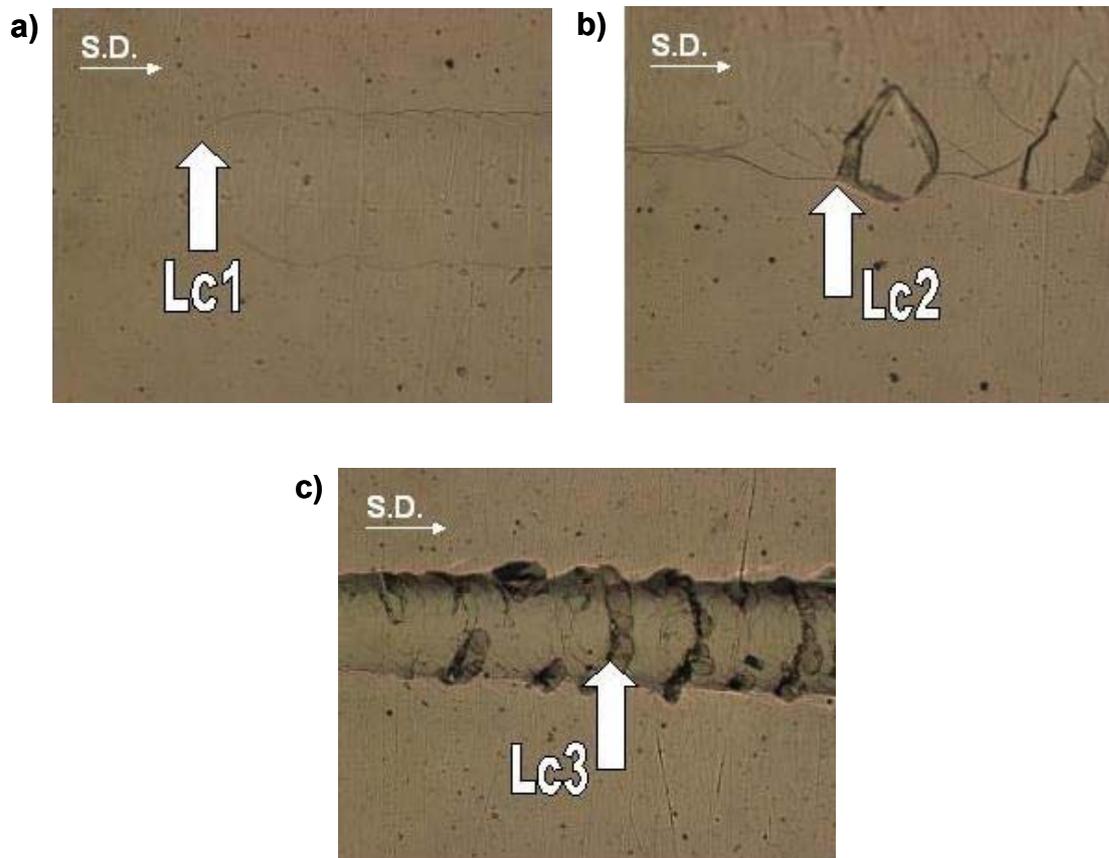
Figure 6. Micrographs of critical load failure events for the CrN coating. Scratch direction (SD) is from left to right. a) LC1; b) LC2; c) LC3.

micrographs of the CrN failure events (**Figure 6**) were taken from scratches performed at NPL.

Scratch testing of the CrN coating showed a common mode of damage progression for all coupons. As scratch loading increased, forward chevron cracks formed at the side of the

scratch (LC_1 failure mechanism, **Figure 6a**). When the crack spacing was sufficiently close, cohesive spallation along crack borders occurred (LC_2 failure mechanism, **Figure 6b**). This was followed by gross interfacial shell shaped spallation (LC_3 failure mechanism, **Figure 6c**) as the cracks propagated over the scratch width and coating was removed. As load increased further there was an increasing density of conformal type buckling cracks, gross reverse chevron cracks with micro-spallation on the trailing edges, and a discontinuous ductile perforation through the coating.

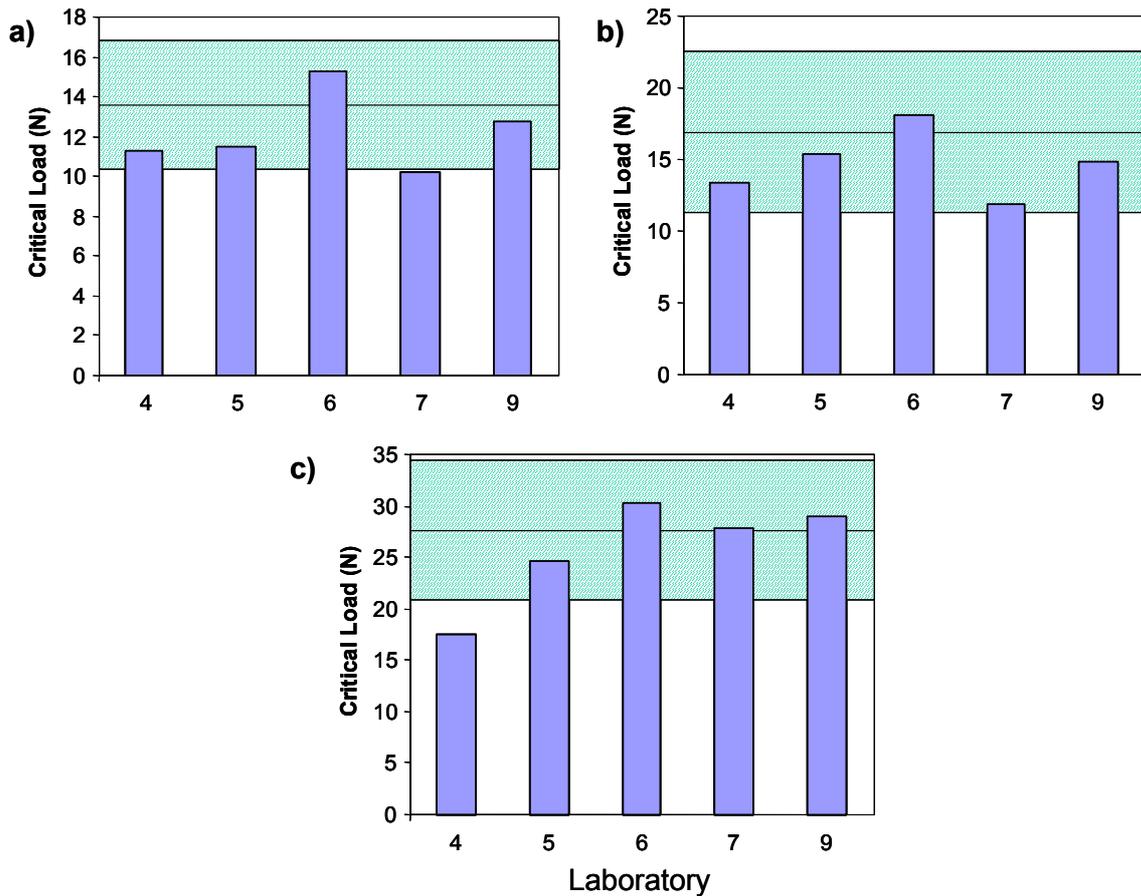
Figure 7. ILE critical loads for the BCR-692 diamond-like carbon coated scratch test reference material. Shaded regions indicate upper and lower verification ranges for critical load. a) LC_1 ; b) LC_2 ; c) LC_3 .

Out of the nine laboratories undertaking scratch testing five submitted data for the DLC reference material (**Figure 7**). This material has well characterised failure mechanisms at certified values of critical load, within upper and lower verification ranges. One laboratory (Lab 7) reported an L_{C1} value $\sim 2\%$ below the lower verification range (**Figure 7a**). As the L_{C2} value returned was similarly low, but just within the verification range, it is likely the stylus was sharper than expected as stylus shape has a greater effect on L_{C1} and L_{C2} values compared to L_{C3} values. Another laboratory (Lab 4) reported an L_{C3} value $\sim 23\%$ below the lower verification range (**Figure 7c**). As this laboratory had a low test standard deviation it was likely that there was either mis-identification of the failure event or some issues with machine stiffness, with the stylus experiencing a stick-slip mechanism at higher loads. All other laboratories reported data within the verification ranges indicating acceptable calibration. Two laboratories who did not submit data for the DLC reference material had the highest and lowest values of critical loads reported for the CrN coupons. This suggests that the equipment was not calibrated or did not conform to the EU scratch testing standard (ENV 1071-3) [11].

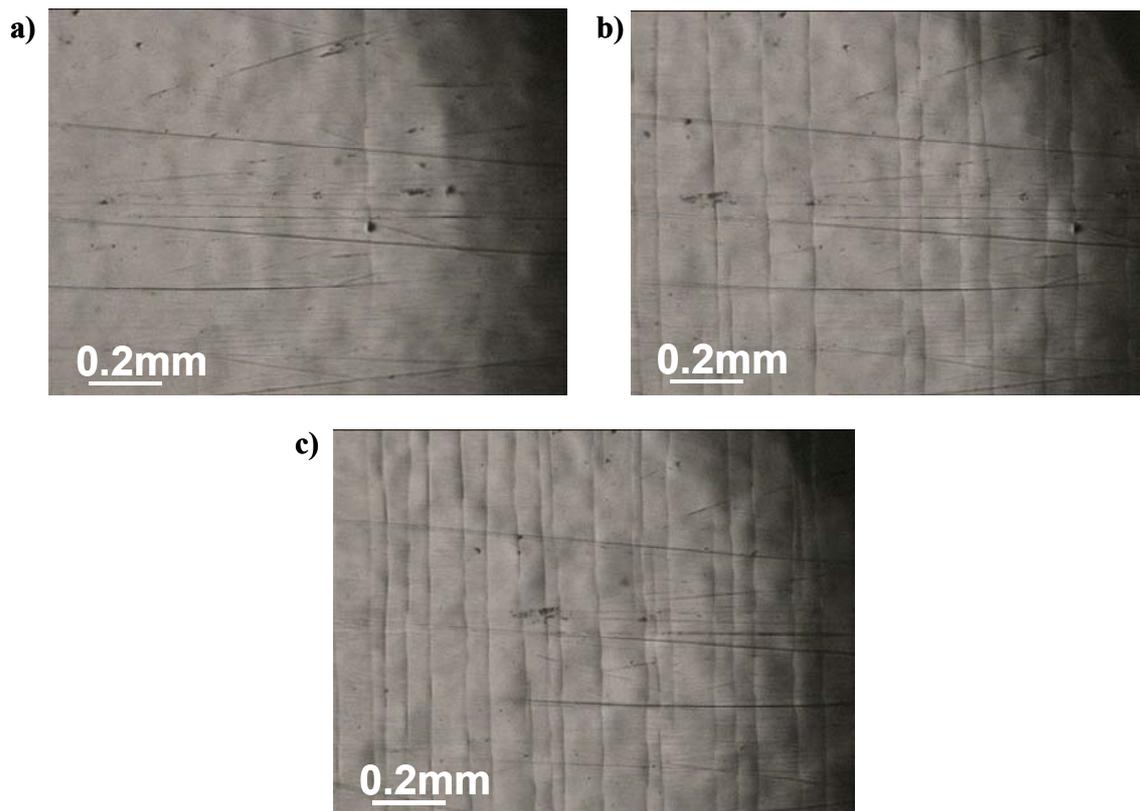
Figure 8. Fracture micrographs from tensile test for CrN coated steel with no interlayer. a) 0.65% strain; b) 0.84% strain; c) 1.10% strain. Loading axis was horizontal relative to micrograph. Delamination between substrate and coating is observed before cracking.

Tensile and four-point bend tests were undertaken at two laboratories as an extension to the main ILE. Test conditions are shown in **Table 2**. No coating spallation was observed at the maximum strain (7%) by either laboratory so adhesion values could not be calculated. The expected coating failure mechanism was through-thickness cracking followed by spallation of the coating as cracks propagated along the coating-substrate interface. However, micrographs taken throughout the tensile test by Lab 1 showed a different mechanism: delamination along the interface followed by through-thickness cracking (**Fig. 8**). Onset of coating failure was detected by acoustic emission (Lab 1) and by iterative testing (Lab 2). The iterative test method involved performing several tests on fresh samples, increasing the maximum strain for each test and looking for evidence of fracture optically. It was expected that the values of strain at first fracture for the nominally similar CrN coatings would be close for both interlayer thickness and test type. Trends of first-fracture strain vs. interlayer thickness were opposite between labs, as shown in **Table 4**. During both tensile and four-point bend tests the acoustic emission trace remained at a low background level until a sharp rise, attributed to fracture events, was detected. First-fracture strain was calculated from this point. Laboratory 2 recorded self-consistent strains, whereas laboratory 1 did not, suggesting that the iterative test method was better at detecting the first-fracture event than acoustic emission.

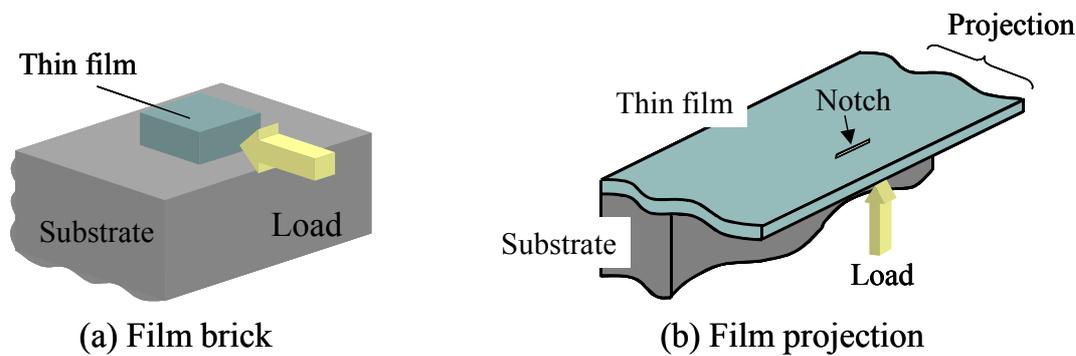
Figure A1. Two specimen configurations

In order to evaluate the toughness of interface and the toughness of films, samples were processed into two kinds of specimen configurations. These are schematically illustrated in **Figure A1**, and here we call them as "film brick" and "film projection", respectively. The interface toughness was measured using film bricks, while film projections were used to evaluate the film toughness. The film brick was loaded horizontally by a diamond needle. At a certain load level, the film brick was pushed off away, when the crack ran unstably along the interface. Toughness of interface was estimated by referring the experimental result to the simulation of crack extension with assumed values of toughness. In the film projection, a notch was set parallel to the edge of projection. Transverse load was applied at the intersection of projection edge and the perpendicular bisector of the notch. The crack extended unstably from the notch tip, and the toughness was calculated with the load at the point of unstable fracture.
